Geotechnical Report

Quinhagak Street Reconstruction

MOA PM&E Project No. 21-13

January 2023

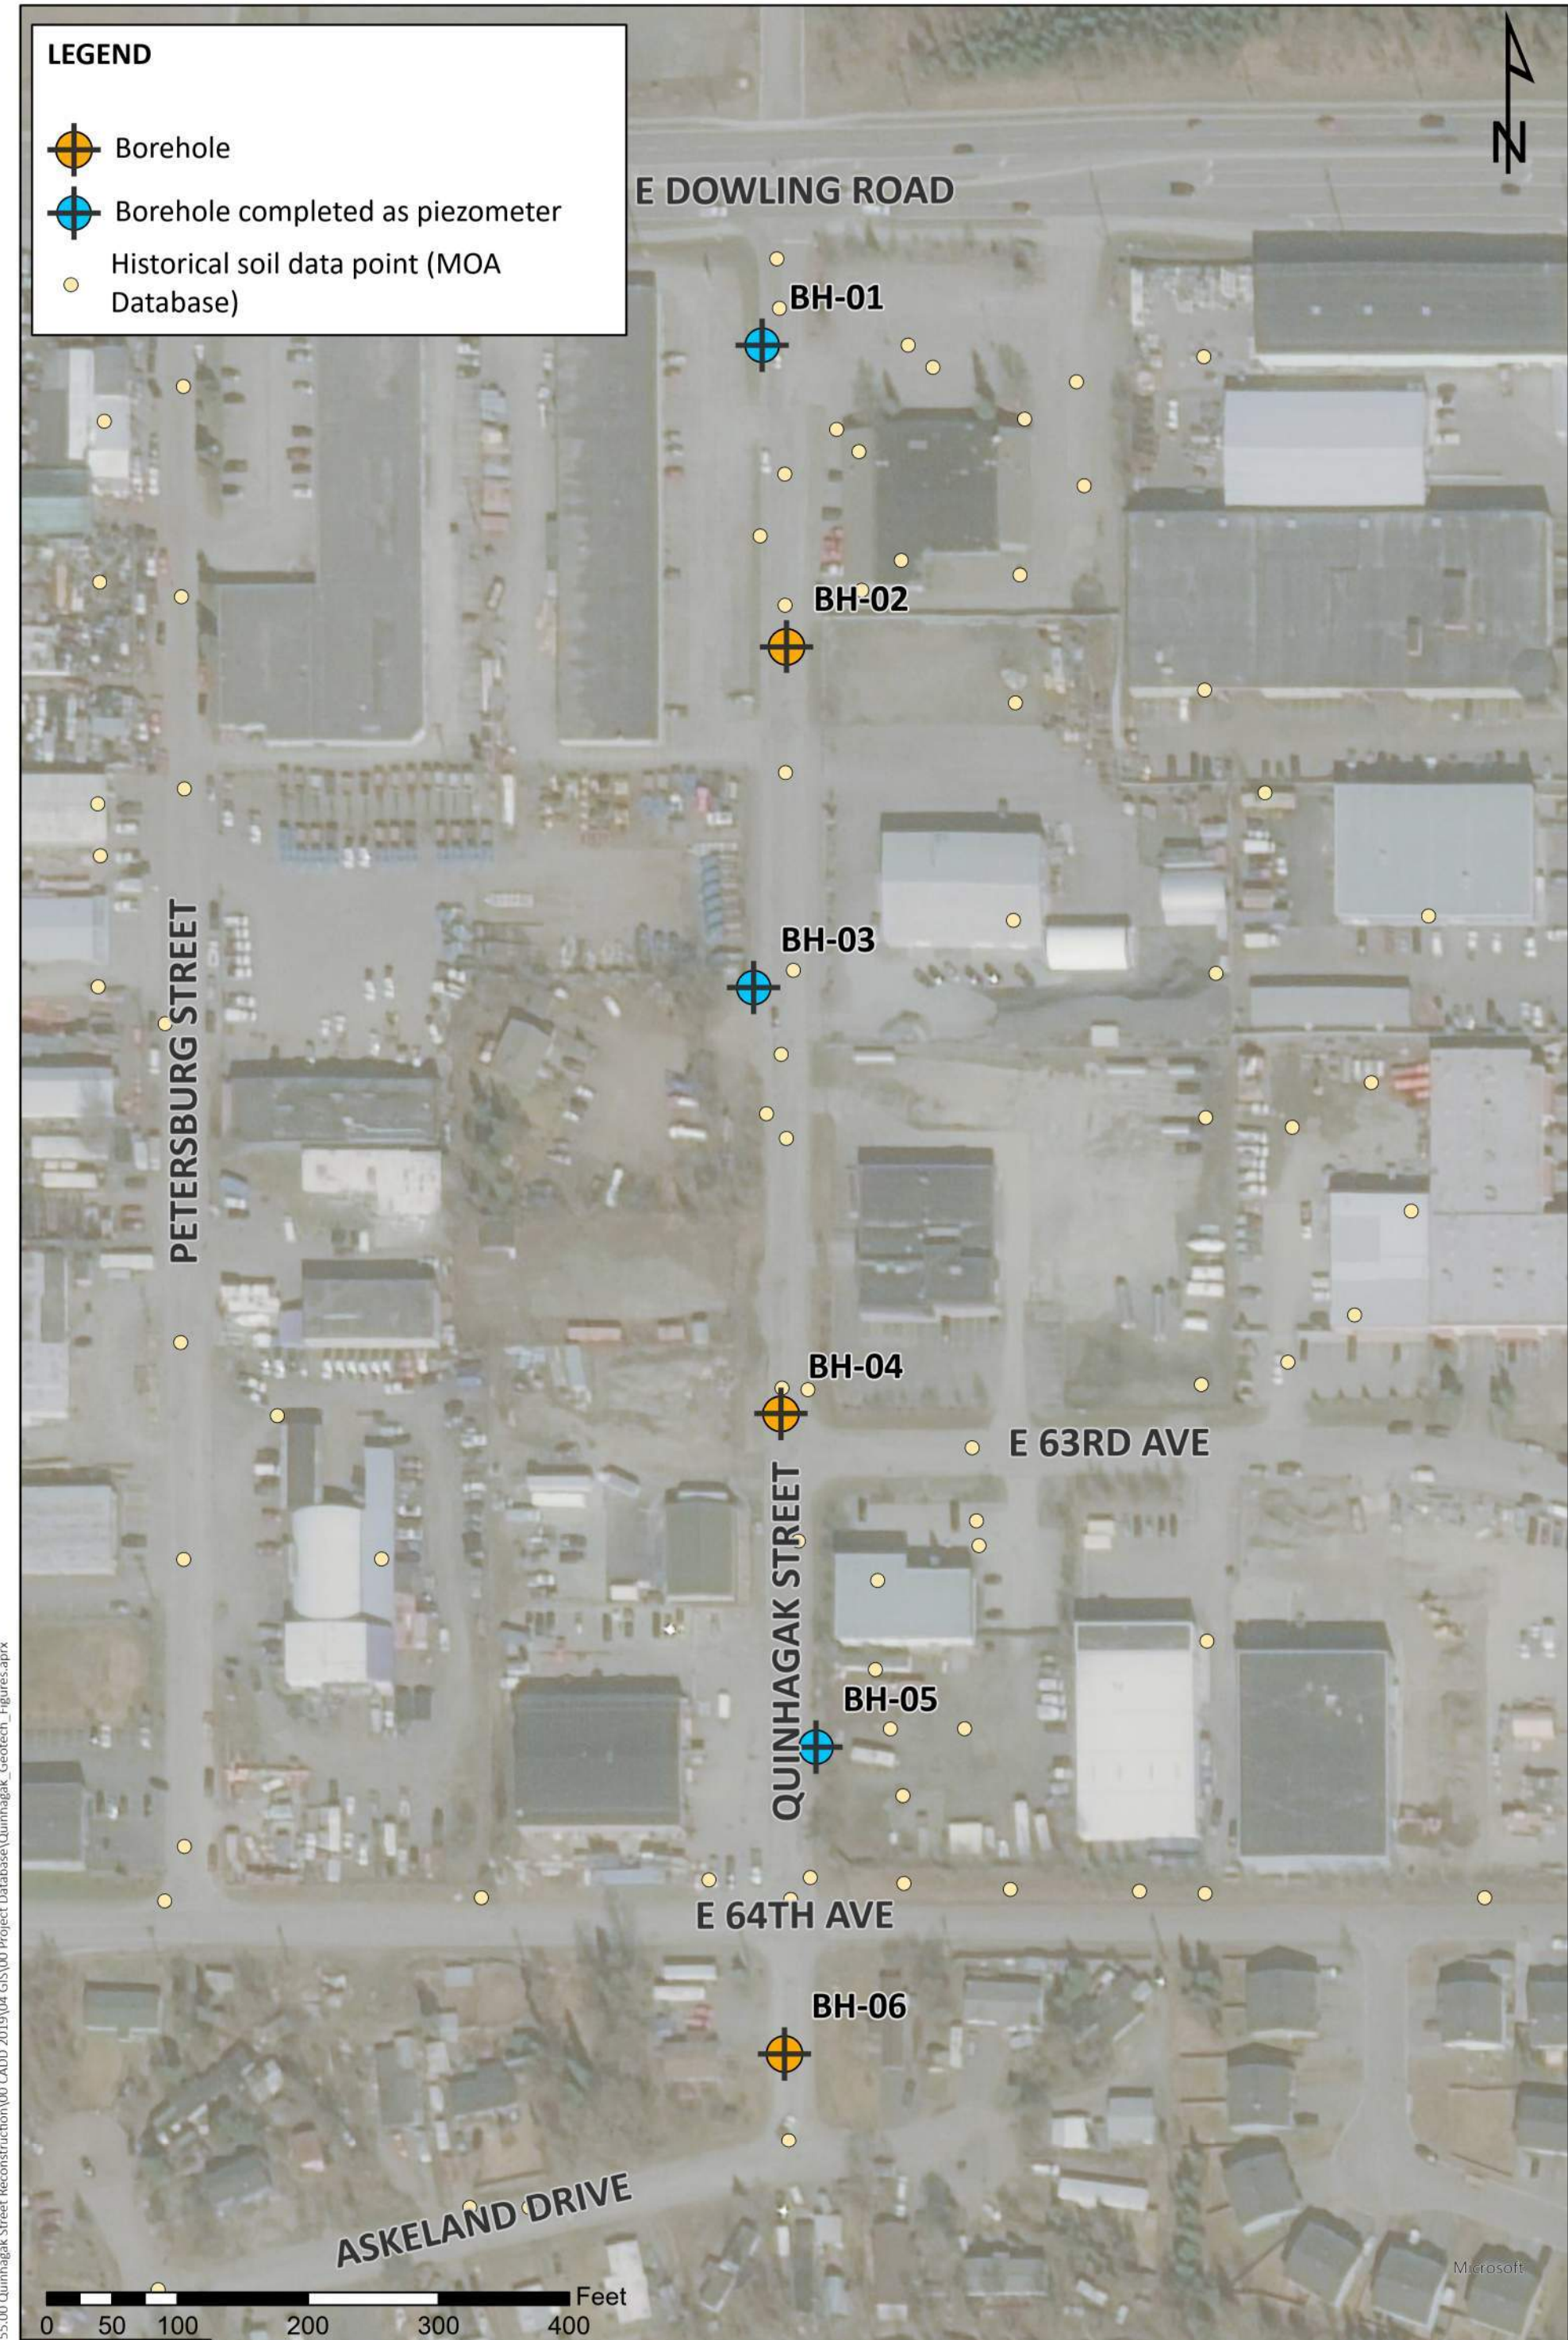
A layer of peat was encountered in BH-03 from approximately 1.0 to 2.5 feet BGS. The moisture content was 164 percent. BH-03 was located just off the road surface in the gravel lot to the west of the roadway (Figure 2). Peat was not encountered in any other borings.
